Manhole Inspection Summary

Manhole # S13MM_014MH

Insp Date: **2/23/09 9:41 AM**

Location Address: **2318 POPLAR GROVE ST**

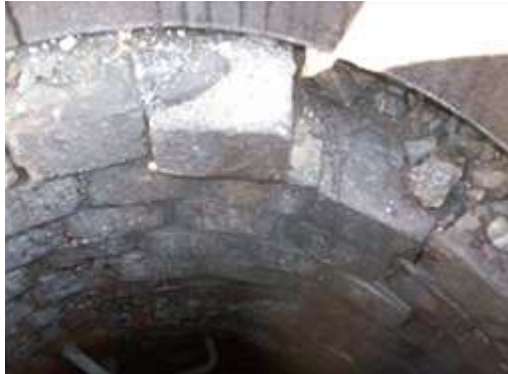
Defect 1

Condition: ☐ Sound ☐ Cracked ☐ Root Intrusion ☒ **Loose Brick** ☐ Deteriorated

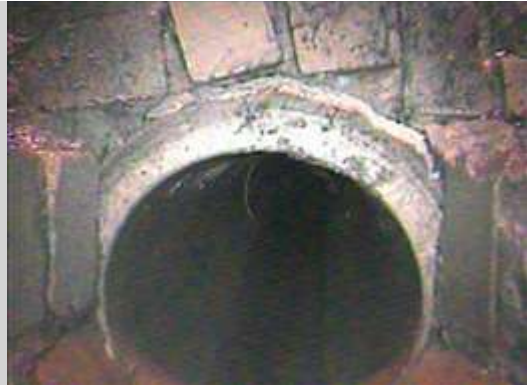
12 O'Clock Outflow

8 in. Circular Gravity Sewer
Pipe Out @ 12 O'Clock

Pipe Height: (in.) Direct
Pipe Material: **Clay** ☐ Pipe Lined
Invert Depth: **7.84** (ft.) Flow Characteristics: **Slow**
Deposits: ☒ None ☐ Mud ☐ Sludge ☐ Debris ☐ Grease
Silt Depth: (in.) Deposits Extent:
Infiltration: **None** Pipe Seal Cond: **Sound**

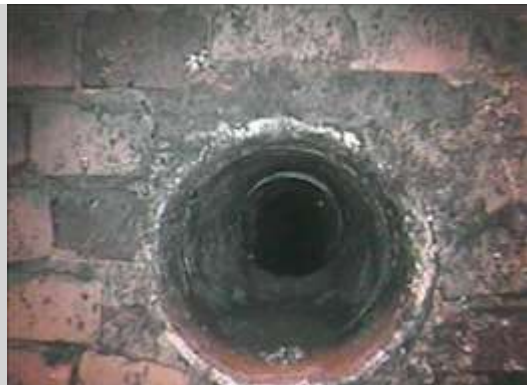
3 O'Clock Inflow

8 in. Circular Gravity Sewer
Pipe In @ 3 O'Clock

Pipe Height: (in.) Direct
Pipe Material: **Clay** ☐ Pipe Lined
Invert Depth: **6.91** (ft.) Flow Characteristics: **Slow**
Deposits: ☒ None ☐ Mud ☐ Sludge ☐ Debris ☐ Grease
Silt Depth: (in.) Deposits Extent:
Infiltration: **None** Pipe Seal Cond: **Sound**

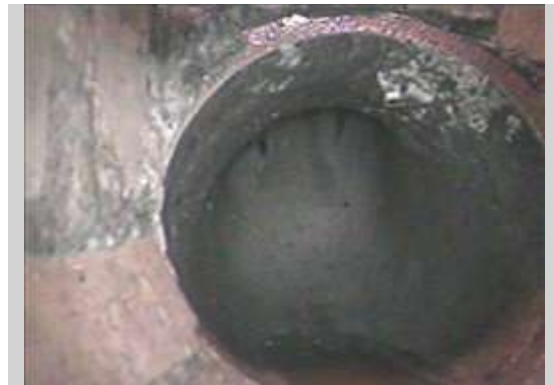
Drop In @ 3 O'Clock

Drop: **Outside Direct**
Angled: Reading: (ft.)
Inv Depth: **7.80** (ft.)
Drop Condition: **Open**
